ANNUAL REPORT FOR 2006

Campbell Creek Mitigation Site
Beaufort County
TIP No. R-2510WM

Natural Environment Unit & Roadside Environmental Unit
North Carolina Department of Transportation
December 2006

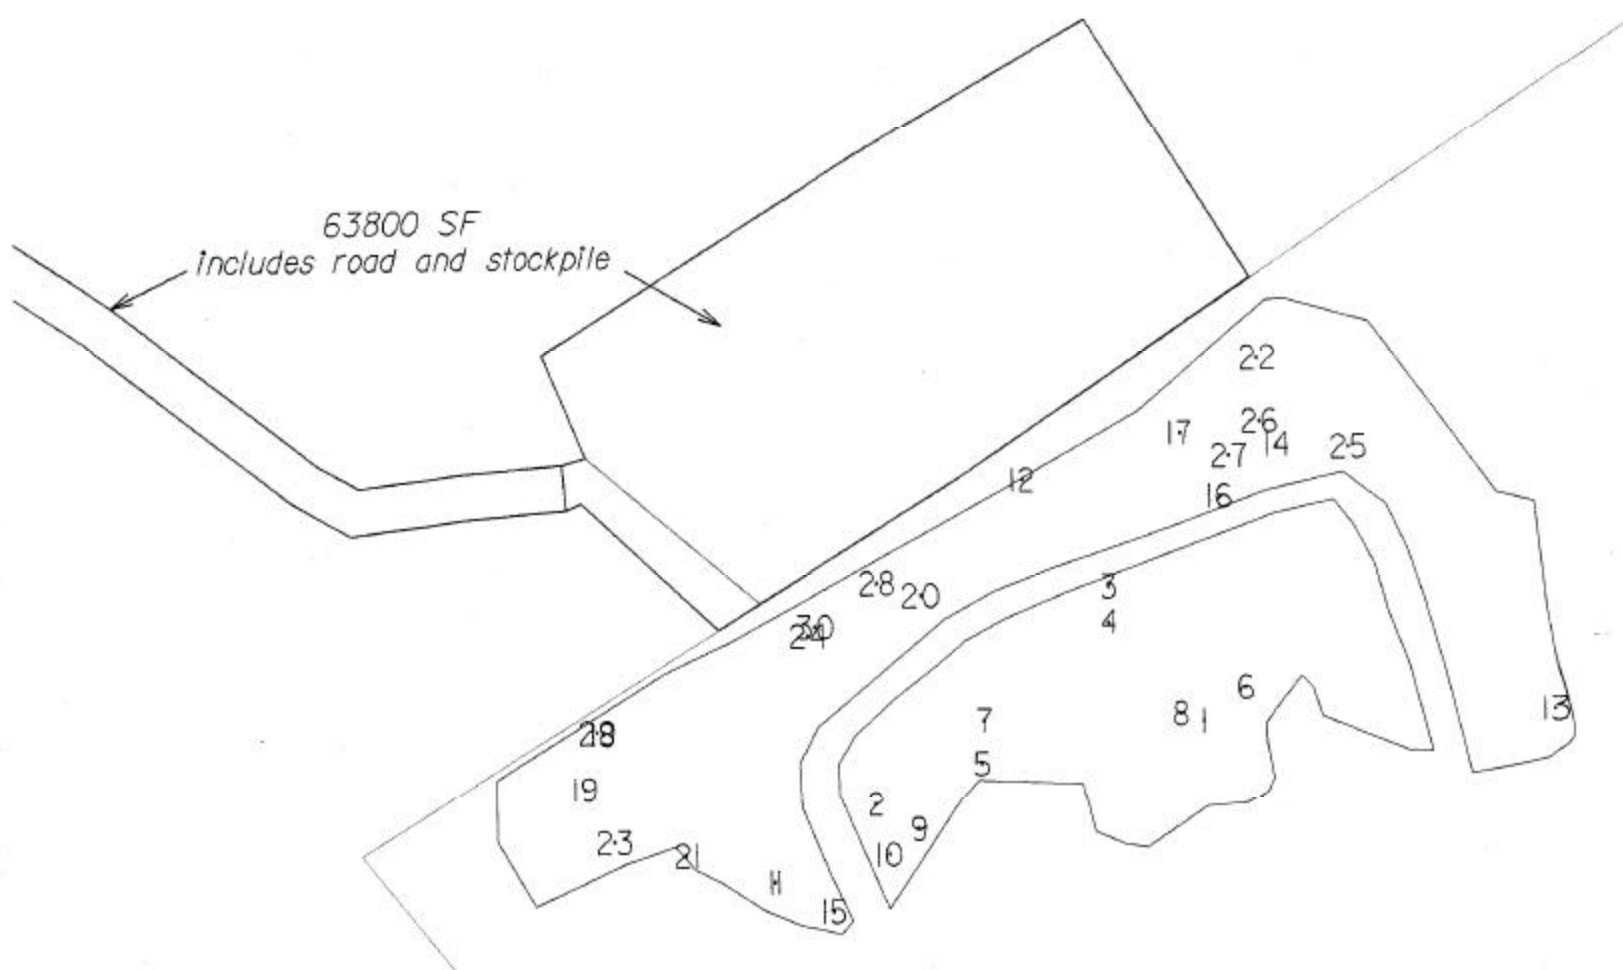
*Campbell Creek Mitigation Site
2006 Marsh Grass Random Points*

Plot #	Scale Factor	<i>Cladium jamaicense</i>	<i>Juncus roemerianus</i>	Frequency	Comments
1	0.0				Bare Ground
2	1.0		✓	✓	
3	2.0		✓	✓	
4	1.0		✓	✓	
5	0.0				Bare Ground
6	0.0				Bare Ground
7	0.0				Bare Ground
8	0.0				Bare Ground
9	0.0				Bare Ground
10	0.0				Bare Ground
11	1.0	✓		✓	
12	1.0	✓	✓	✓	
13	1.0	✓		✓	<i>Cyperus</i> sp.
14	0.0				Bare Ground
15	0.0				Bare Ground
16	1.0	✓		✓	
17	0.0				Bare Ground
18	2.0	✓	✓	✓	
19	1.0		✓	✓	
20	1.0		✓	✓	
21	1.0		✓	✓	<i>Pluchea</i> sp. and wire grass
22	0.0				Bare Ground
23	0.0				Bare Ground
24	1.0	✓		✓	
25	0.0				Bare Ground
26	1.0	✓		✓	
27	2.0		✓	✓	
28	1.0		✓	✓	
29	2.0	✓	✓	✓	
30	1.0	✓		✓	
Frequency (Percentage of Plots with Desired Species)				57.0%	
Sum Scale Value				21.0	
Total Number of Plots				30	
Vegetative Cover (Scale Value)				0.7

Percent Frequency of Target Species **57 %**
Frequency of 70% required.

Vegetative Cover Scale Value **0.7**
Scale Value of 5 required for year 5.

The site was planted in June 2006. The planted vegetation is surviving in certain sections of the site. Due to the low survival numbers, NCDOT proposes to replant the site in 2007.

For the vegetation monitoring in the marsh grass area, the target species and scale values were 57% and 0.7, respectively. The planted vegetation is surviving in certain sections of the site. Due to the low survival numbers after the first year of monitoring, NCDOT proposes to replant the site in 2007.
